# Common Metallurgical Defects in Grey Cast Irons

## Causes and Cures

## Abstract

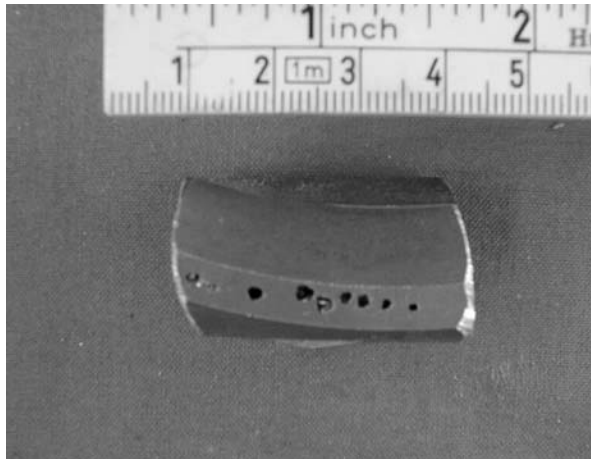
**Figure 1. Hydrogen pinhole.**

These may be considered to be one of the most expensive defects as they are not normally revealed until after machining. They can be found both in grey and ductile irons and tend to appear as small spherical holes just beneath the casting surface. The inner surface of the hole will have a continuous graphite lining and hence appear to be black and shiny on examination. This precipitation of graphite onto the surface results in a graphite depleted area around the hydrogen gas hole as shown in Figure 1.

Hydrogen pinholes can be caused by several factors, either alone or in combination. Most commonly, high levels of aluminium or titanium in the base iron causes a reaction with moisture from the greensand, damp tools or wet refractories. Other sources of moisture could be damp or oily charge materials (including rust), a build up of dead clay in the sand system which will tend to retain moisture or the use of old cores, which have picked up moisture from humid atmospheres.

**Example of hydrogen porosity revealed on machining.**

Pinholes may be prevented, or the occurrence reduced, by restricting the aluminium content of the base metal below 200ppm and minimising the titanium content. Careful control of steel scrap, avoidance of CG iron returns (if made using Ti) and elimination of enamelled scrap will help in this respect. Some pig irons can also contain titanium.

Care should be taken to fully dry refractory patches and coated tools before use and sufficient new sand added to the moulding system to prevent build up of dead clay. Moisture in the system should preferably be below 3%. Cores and water-based coatings should be fully cured and dry before the metal is poured into the mould.

Increasing metal pouring temperatures and carbon equivalents have also been noted to reduce the incidence of this particular defect.

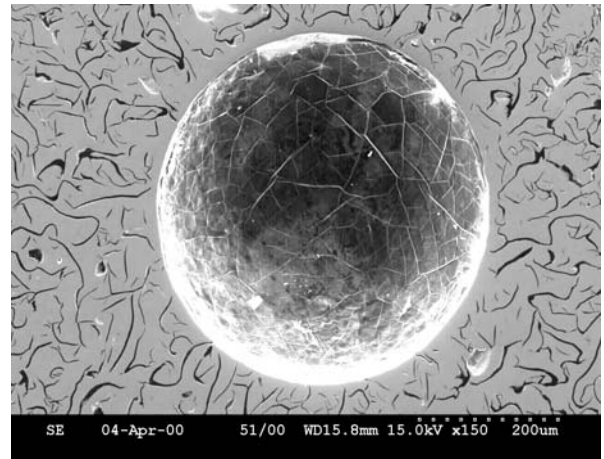
**Close-up of hydrogen pinhole revealing inner graphite lining.**

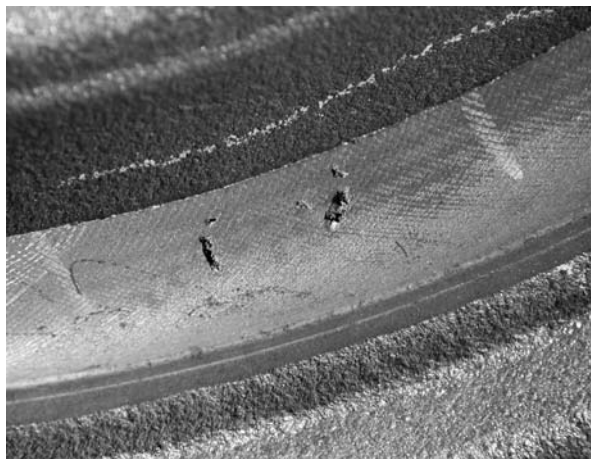
**Figure 2. Nitrogen Blowholes**

**Example of Nitrogen porosity defect in grey iron revealed on machining.**

Nitrogen blowholes may be either a surface defect or a sub-surface occurrence. The example shown in figure 2 was only revealed on machining, thus being detected at the most expensive post-foundry finishing operation. Blowholes appear more frequently in medium to heavy section thicknesses and are often adjacent to resin bonded core or mould materials. The holes, or fissures, are normally irregular in shape (as opposed to the more spherical hydrogen holes) and are perpendicular to the casting surface, protruding some millimetres into the casting. The

inner surface of the hole has a continuous or dis-continuous graphite lining coupled with the subsequent decarburisation in the immediate surrounding matrix. This is clearly seen in figure 2. Also seen in this figure are dendrites, which have grown into the hole. On occasions, the graphite flakes are seen to have become shorter and thicker, this being a typical sign of high nitrogen.

Nitrogen fissures are caused simply by excess nitrogen in the system. In cupola melted grey irons, this comes from high proportions of steel scrap in the charge which require high levels of coke, whereas in induction melting, poor quality, high nitrogen containing carburiser is normally the cause. The use of some resins in the production of cores or moulds can also lead to nitrogen pick up locally within the casting, particularly at a potential hot spot.

Restricting the dissolved nitrogen content to 80 ppm in medium to heavy sections and 120ppm in thin, uncured sections will normally not give nitrogen blowhole problems. In addition, careful selection of raw materials will also help reduce the potential for blowhole problems. Titanium and zirconium are known to neutralise the effects of nitrogen by producing carbo-nitrides, however care should be taken when using titanium as this can then promote hydrogen pinholes in the presence of aluminium and moisture as previously discussed. Increases in pouring temperature and carbon equivalent are also known to reduce the incidence of nitrogen defects.

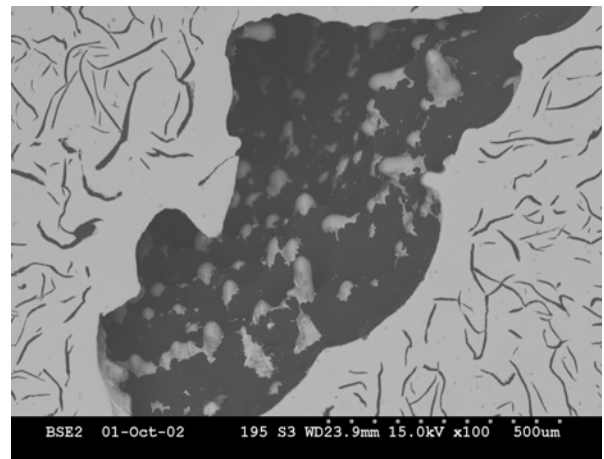
**Close-up of defect showing flake depleted rim.**

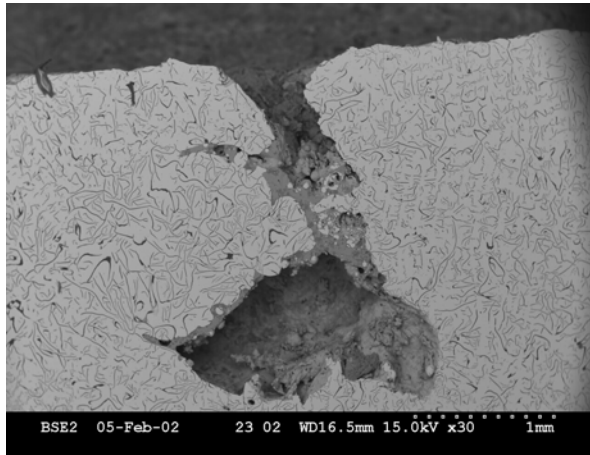
The third of the common gas defects is the carbon monoxide blowhole. Figure 3 shows an example of this type of defect, which can normally be seen as a surface blow.

The carbon monoxide blow can appear as a hole a few millimetres across, as in the illustration here, or in large castings the hole can be large enough to put a fist into. Normally seen in conjunction with slag and clouds of manganese sulphides, it is also possible to see dendrites protruding from the inner surfaces of the hole.

**Example of surface slag blowhole in grey iron.**  
**Figure 3. Carbon monoxide blowhole.**

The most common cause of this problem is the failure to totally empty ladles between taps. This results in a lowering of the overall metal temperature and a build up of cold manganese sulphide/oxide rich slags. Eventually, the point is reached where a metal/slag reaction takes place as;

The defect may also be attributed to excess manganese and/or sulphur in the system. These should be balanced according to the equation:

Carbon monoxide blowholes can normally be eliminated by ensuring a complete emptying of ladles between taps, operating with clean ladles and preventing slag build up on the refractory. Increasing metal temperature can also help.

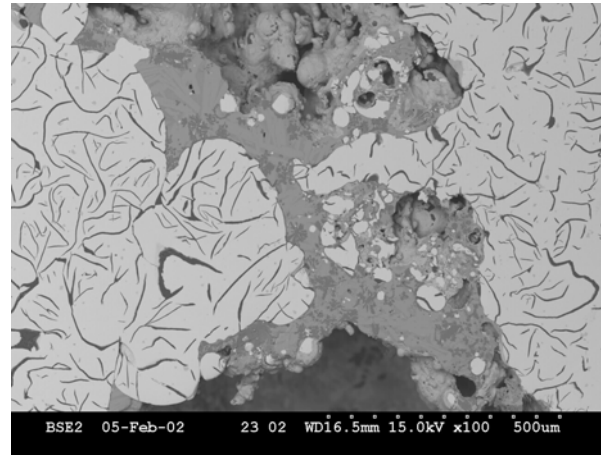
**Close-up of defect showing slag cluster.**

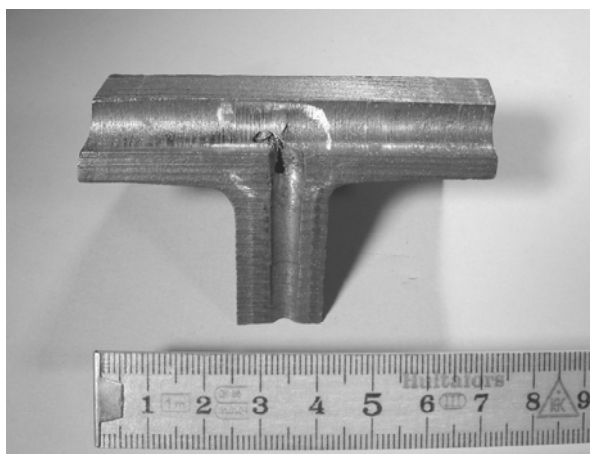
**Figure 4. Example of a hot-spot shrinkage defect.**

**Overview of the position of the shrinkage. The defect was revealed after machining and was located in the centre of the casting section with T-shape.**

The example shown in Figure 4 is a typical shrinkage defect, typically the surface of the shrinkage hole will show dendrites, but without any graphitic lining as would be seen in a gas related defect. In the case illustrated, the shrinkage appears at the thermal centre of the casting and the cause was attributed to the sharp radii and to poor metal flow design. Soft sand in the vicinity of the defect may have been a contributory factor in this case.

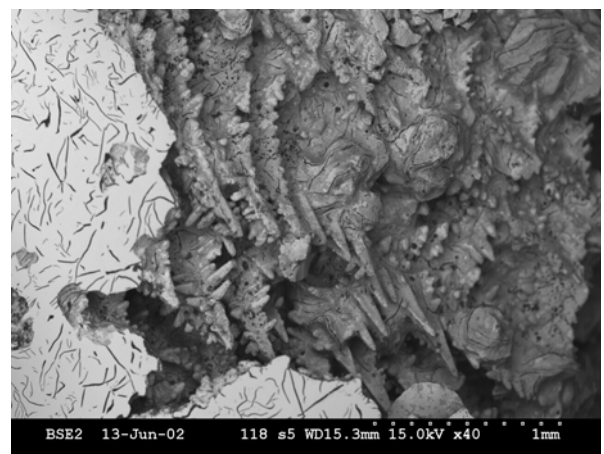
**Close-up of the shrinkage showing dendrites and metallic surface.**

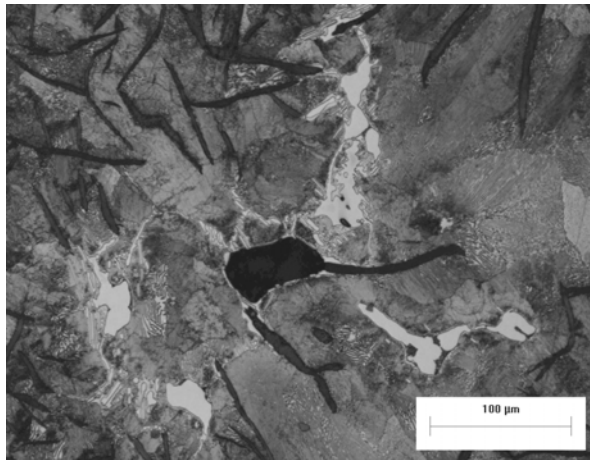
**Figure 5. Example of grain boundary carbides**

Today's industry has to cope with decreases in the quality of affordable steel scrap. Often, the trace element content of the steel is higher than has been found previously and there is a resulting increase in the incidence of inter-cellular carbides. These are particularly noted in thicker section castings where the slow solidification time allows for segregation and a build up in the concentration of deleterious elements, such as molybdenum, vanadium, manganese, chromium and titanium.

Avoidance of grain boundary carbides is achieved by careful control of raw materials, particularly steel scrap and by optimising the inoculant addition. Increases in carbon equivalent may also help to disperse the undesirable elements.

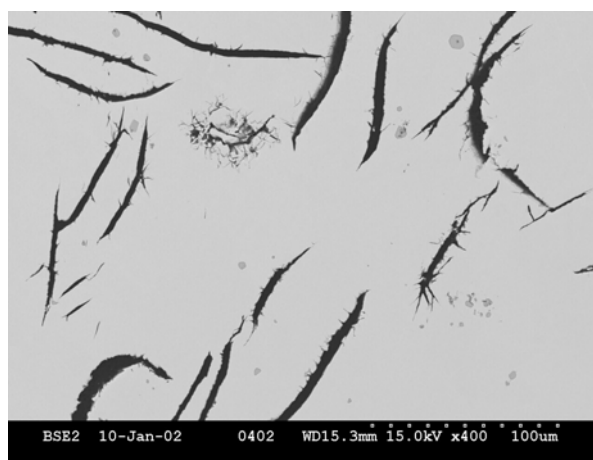
Figure 6 shows a classical example of Widmanstätten graphite. This effect, sometimes referred to as “spiky graphite” is found when levels of the trace elements lead, bismuth or antimony become too high.

Antimony will promote Widmanstätten graphite in the presence of hydrogen, particularly in heavier section castings, as will bismuth. The usual cause of this defect is the presence of lead, a 0.0005% addition is likely to cause Widmanstätten graphite forms.

Overview of the graphite structure.

Once lead has appeared in grey iron, there is no real cure except to use a rare earth containing inoculant/preconditioner to try to scavenge the lead from the iron.

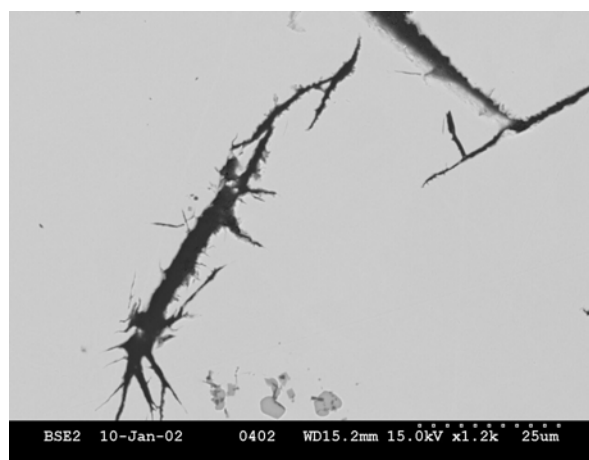
Close-up of one of the graphite lamellas.

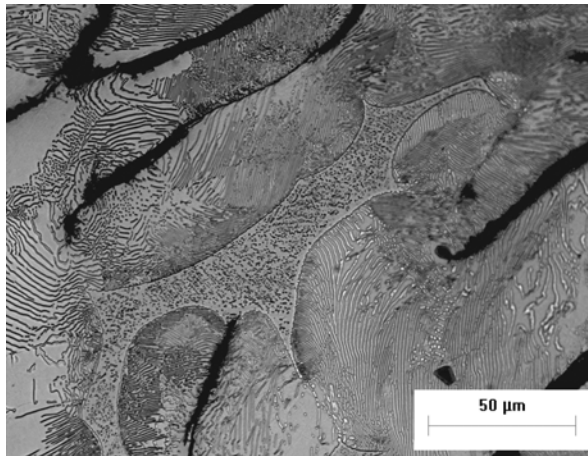
**Steadite in thick section.**

Steadite, more commonly known as the phosphide eutectic, is really a precipitation of iron phosphides. Normally this is not regarded as a defect unless excess phosphorus enters the system and clusters are detected at the grain boundaries.

The cure for excess steadite, apart from reducing the levels of phosphorous, is to disperse the phosphorous within the casting by improving inoculation or to increase the solidification rate. Care should be taken in the selection of scrap to avoid domestic heating castings and analysis should be made of the pig iron as some brands contain higher levels of phosphorous.

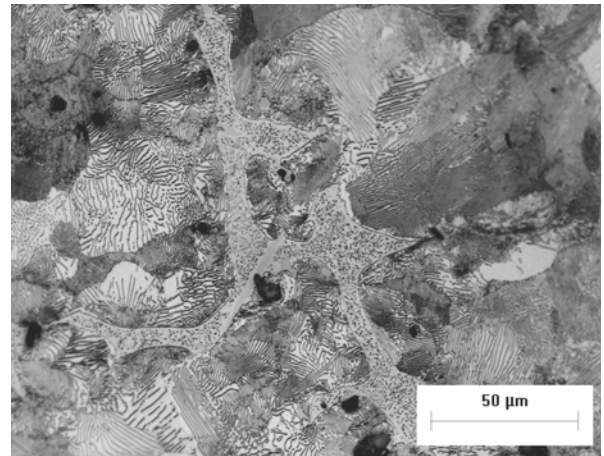
**Steadite in thin section.**

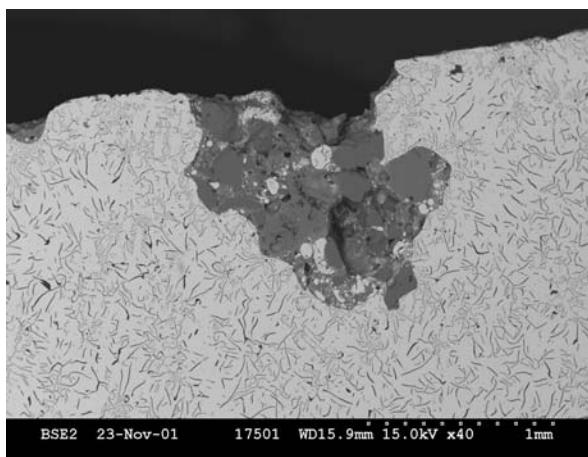
**Example of grey iron slag inclusion cluster.**  
**Figure 8. Example of slag inclusions**

Slag inclusions may be found both at the surface of the casting, as illustrated here, or within the body of the casting. They are recognisable as having no decarburisation associated with them and the slag usually seems to have several different phases within the particle.

Slag defects are caused by inadequate slag removal during the melting and pouring phase or by a build up of slag in the pouring ladle or receiver – see also the section on the carbon monoxide blowhole. Slag traps or filters built into the running system often help with the removal of slag, but do not help with the root cause of slag build up and are no substitute for good metal cleaning practise. Slag may also be formed if there is excessive turbulence in the running system or metal is poured from some height. Examination of the runner design or time spent watching the ladle operator's practise is well spent.

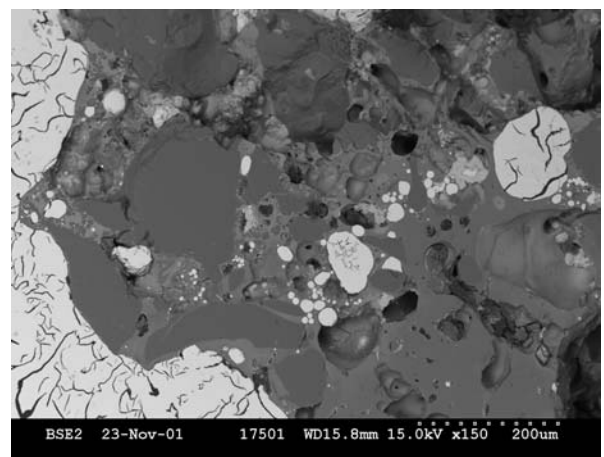
**Close-up of slag cluster showing various phases.**

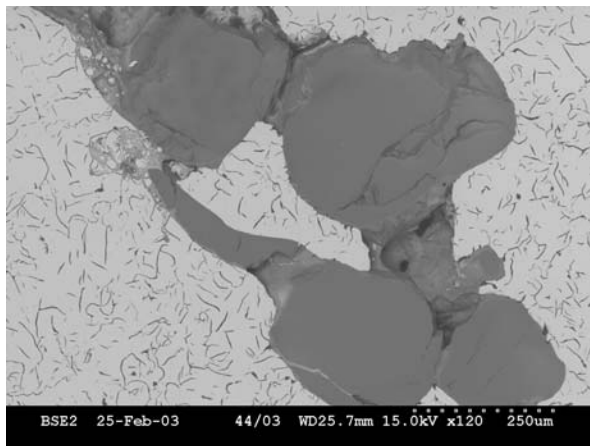
The final defect examined in this paper is concerned with sand. As seen in Figure 9, sand can be distinguished from slag in that it has a single phase and the sand grains are relatively regular in shape.

**Figure 9. Sand grain inclusions**

Sand is normally generated within the mould, loose sand around the downsprue or erosion of sand if the metal is dropping a large distance onto sand at the bottom of the sprue. Sharp corners are also a common cause of sand erosion. Care should be taken to blow loose sand from the mould during the assembly of the mould and frequent examination of pattern plates in horizontal moulding machines should be made to ensure that nothing is sticking to the plate.

As with slag inclusions, avoidance of excess turbulence when pouring will help to avoid subsequent problems.

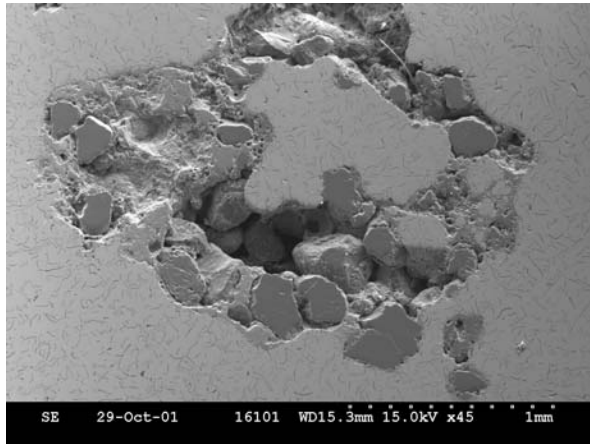
**Figure 10. Sand grains enveloped in slag**

On frequent occasions, sand grains have been noted within an envelope of slag, as in Figure 10. Viscous slags coming from the melting/pouring processes can drag sand grains from even a well bonded surface, emphasising the importance of good metal preparation prior to casting
